# OLIVER ARCHITECTURE

**LAUREL COURT  
22 MINSTER PRECINCTS  
PETERBOROUGH  
PE1 1YA**

**LISTED BUILDING CONSENT APPLICATION  
FOR EMERGENCY REPAIRS AND INVESTIGATION**

**DESIGN AND ACCESS STATEMENT  
AND HERITAGE STATEMENT**

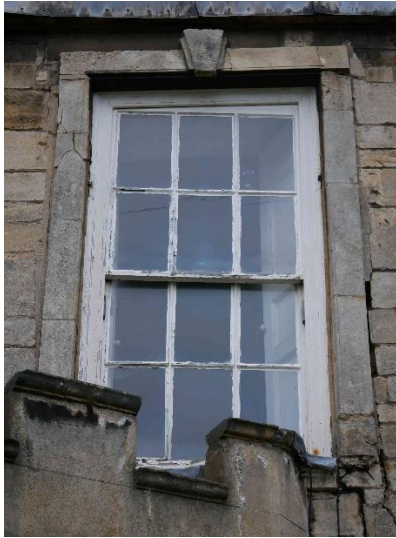
- 5.2 The scope of work, as described in section 2 of this report (which is taken verbatim from the Outline Schedule of Work for the proposals). Window W10 (at first floor level on the main façade, looking west onto the Cloister) has been selected as the focus of investigation, as a representative example of the many stone-framed sash windows exhibiting severe structural deformation, with a 20<sup>th</sup> century steel strap to the lintel. It is also close to door D02, which needs a large fragment of stone refixing (which has become detached due to a rusting iron cramp). The proposed scaffold will extend from here to the parapet, in order to explore the lead-covered steel straps on the façade as well as the face-bedded stonework to the parapet, to improve our knowledge of these features. Some internal opening up is proposed to explore

- 2.1.2 **Window W10:** Carefully remove the two sashes and then remove the joinery frame. Allow for detailed survey by the architect and engineer of the stone surround, including the metal plate below the lintel. Provide suitable temporary support. Carefully remove the stone surround, salvaging damaged masonry. Remove the metal plate to the soffit. Structural engineer to specify remedial work to lintel. Architect to specify repairs to masonry surround, with new Ketton stone as required in lime mortar. Carry out joinery repairs to the frame and sashes, overhaul and redecorate and reinstate in position, ensuring correct operation. Fill the gap between the joinery and stonework surround in burnt sand mastic.
